Building 2-68 Underground Fuel Storage Tank Soil Removal Completion Report

Boeing Plant 2 Seattle/Tukwila, Washington

June 2000

Roy F. Weston, Inc. 700 Fifth Avenue Suite 5700 Seattle, WA 98104-5057

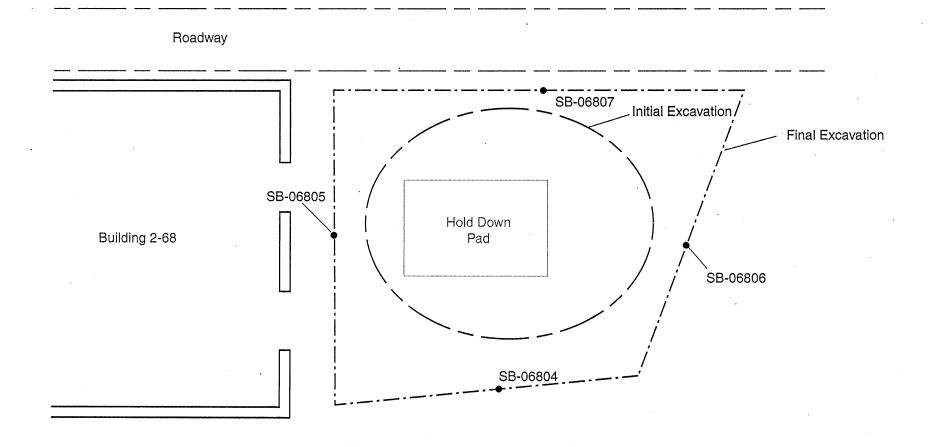
Final Excavation Limits

The final excavation was irregular in shape and was approximately 43 feet long by 32 feet wide. The "hold down" pad was not removed from the bottom of the excavation. Figure 4 shows the excavation configuration and location of confirmatory samples.

Location	Soil Sample Number	TPH Concentration (mg/kg)
South Wall	SB-06804	11U
West Wall	SB-06805	123
East Wall	SB-06806	12U
North Wall	SB-06807	10U

Clean structural overburden (i.e., free of visible staining) 0 to 5 feet bgs was then removed from the east wall and set aside. Four feet of soil was subsequently removed in the horizontal direction from the east wall. At this point, oil staining was not observed in the east wall. A soil sample was collected 1 foot above the water table from the middle of both the east (SB-06806) and north wall (SB-06807).
